**DEPARTMENT OF TRANSPORTATION****DIVISION OF ENGINEERING SERVICES**

Quality Assurance and Source Inspection

Contract #: 04-0120F4Cty: SF/ALA Rte: 80 PM: 13.2/13.9File #: 99.28**WELDING INSPECTION REPORT****Resident Engineer:** Pursell, Gary**Address:** 333 Burma Road**City:** Oakland, CA 94607**Report No:** WIR-002222**Date Inspected:** 23-Apr-2008**Project Name:** SAS Superstructure**Prime Contractor:** American Bridge/Fluor Enterprises, a JV**Contractor:** Japan Steel Works, Ltd.**OSM Arrival Time:** 830**OSM Departure Time:** 1630**Location:** Muroran, Japan**CWI Name:** Rory O'Kane**CWI Present:** Yes No**Inspected CWI report:** Yes No N/A**Rod Oven in Use:** Yes No N/A**Electrode to specification:** Yes No N/A**Weld Procedures Followed:** Yes No N/A**Qualified Welders:** Yes No N/A**Verified Joint Fit-up:** Yes No N/A**Approved Drawings:** Yes No N/A**Approved WPS:** Yes No N/A**Delayed / Cancelled:** Yes No N/A**Bridge No:** 34-0006**Component:** Tower, Jacking and Deviation Saddles**Summary of Items Observed:**

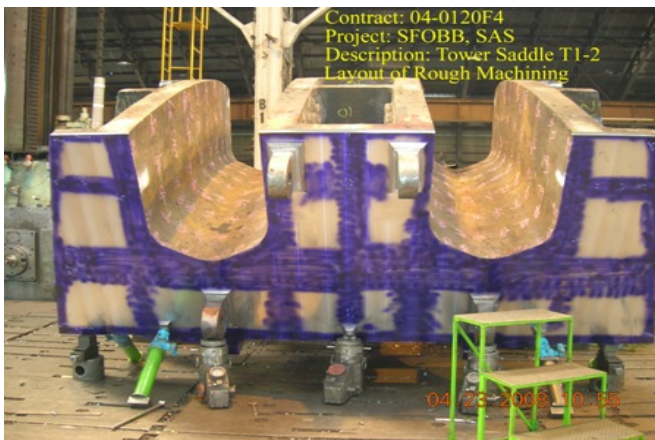
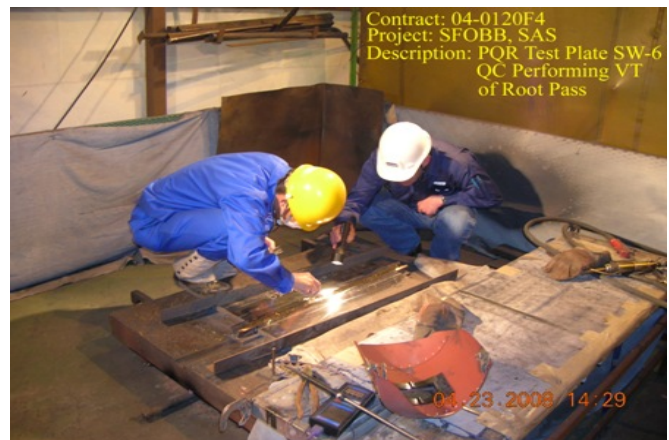
At the conclusion of welding the root pass and interpass cleaning the QC inspector Mr. O'Kane observed porosity in the root pass. At this time JSW Welding Engineer Takaaki Maruya proceeded and instructed the welder Mr. Kouzou to weld single passes utilizing a test piece. The Welding Engineer Mr. Takaaki adjusted the welding parameters which appeared not to rectify the issue of the porosity. At this time Mr. Takaaki checked the gas flow of the shielding gas and the supply hose for leaks which appeared not to be a contributing factor in regards to the porosity issue. At the conclusion of this process of elimination, Mr. Takaaki suspended the PQR testing and informed the QC inspector that it appears that the welding consumable was the contributing factor of the porosity issue. The re-scheduling of the PQR test plate will be determined at a later date.

The following digital photographs illustrate observations of the activities performed on this date.
